Name of Dam: Lake Monocan Dam

Location: Nelson County, State of Virginia

Inventory Number: VA 12502

PHASE I INSPECTION REPORT NATIONAL DAM SAFETY PROGRAM

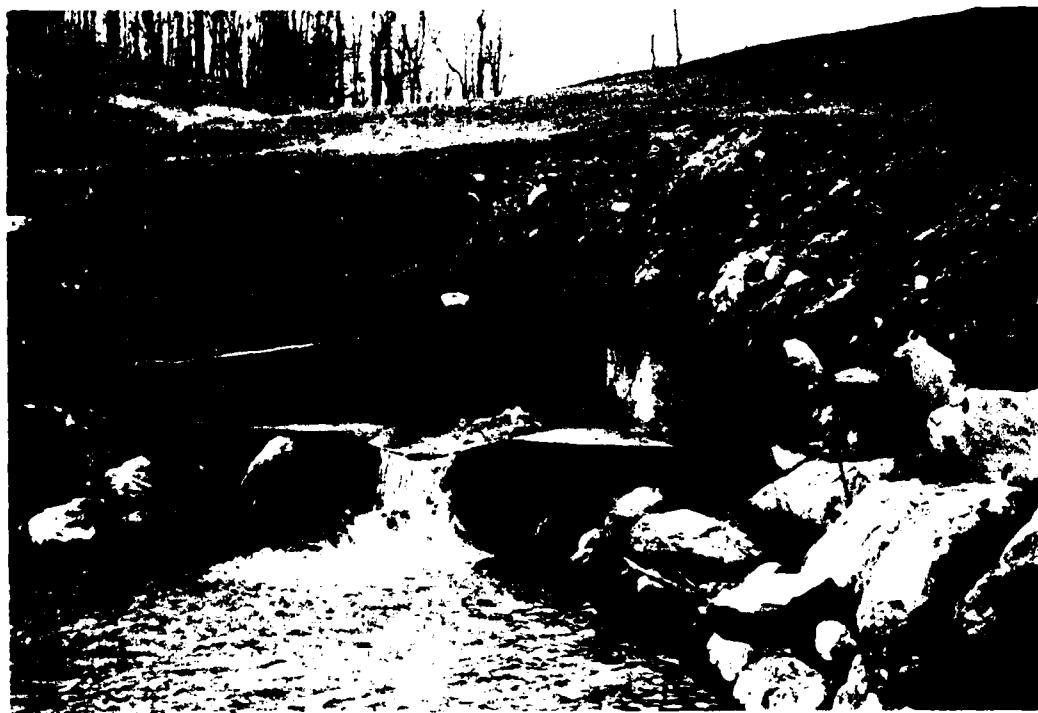
sparse vegetation which were showing signs of minor erosion, particularly the junction between the downstream embankment and the right abutment. The embankment area directly above the spillway outlet was severely eroded due to the lack of vegetation. The owner's representatives stated that plans to remedy the situation are presently underway. Erosion was also noted on the left upstream abutment.

**PHOTO 2. Principal Spillway Outlet Structure;
Erosion Around Outlet Structure**

3.2 Evaluation: The dam is generally in good condition. The major deficiency to be corrected is the erosion occurring at various places, most noticeably on the downstream face above the principal spillway outlet. A qualified geotechnical engineering firm should be engaged to inspect the flow from the toe drain and determine whether the particulate matter is embankment material or material that accidentally entered the drain during installation.
